DIAGNOSIS, DISCOVERY AND SEISMIC STRENGTHENING OF A MILITARY HISTORIC BARRACKS OF 20TH CENTURY in Italy The “ CASERMA PIAVE” of ORVIETO

Nina Avramidou
University of Florence

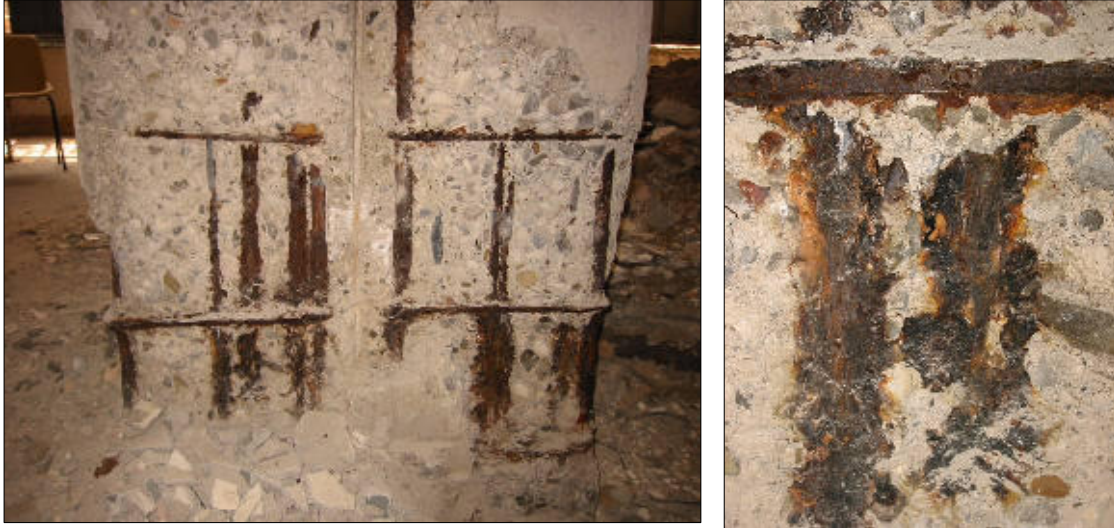
Fig. 6. Corrosion of the steel reinforcement at the bottom of the columns, sector B3

The ordinary maintenance interventions which were previously carried out they only considered the restoration of the damaged concrete at the bottom of the columns of the ground floor, without replacing the corroded metallic bars. The corrosion of these last ones is diffused in all the columns and has reached a loss of 100% of the original section of the metallic bars.

From the examinations lead on the r.c. columns of the building defects attributable to the bad constipation of the concrete emerge, to the lack of employment of spacers of the metallic reinforcements during execution, to the wrong dosage of inert granules and to the defective and insufficient concrete covering.

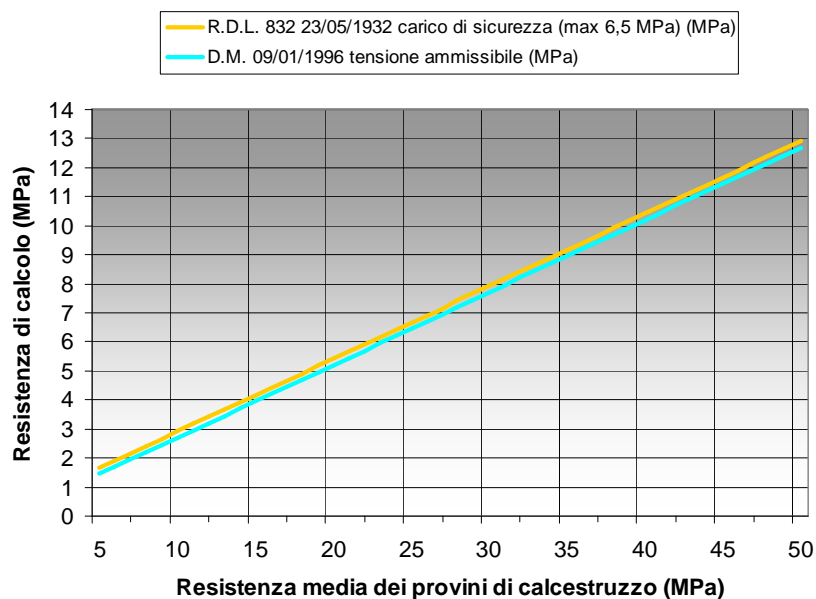
Fig. 8 Compression strength of the concrete carrots versus design strength according to two different normative

It can be interesting to compare, to parity of concrete, the two design strengths. These values are not directly comparable because of the different initial data and methods of calculation used; so, on the base of some simplified hypotheses made it was possible to write up the diagram of fig. 8 in which the values of the "safety load" as well as of the "admissible stresses" are compared, to varying of the average strength of the concrete. The two values turn out to be very similar, and, moreover, repeating the procedure assuming a standard deviation $\delta = 4,56$ MPa instead of $\delta = 5$ Mpa, it is stated that the two values coincide perfectly. This result demonstrates the tight existing tie between the "safety load" of the R.D.L. 1213 of the 29/07/1933 and the "admissible stresses" of the D.M. 09/01/1996, in spite of the differences of the methods of calculation and of the definitions (in particular are observed that the "safety load" of the R.D.L. 832/1932 still do not have the formulation of present statistical formulation in the definition of the "admissible stresses").

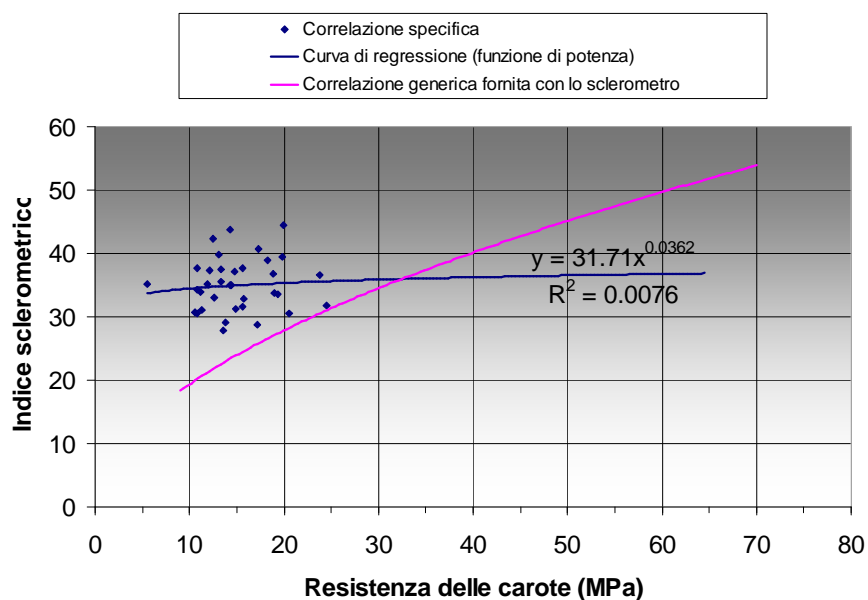
Fig. 9 correlation between sclerometric index and strength measured with compression tests on cylindrical carrots

- The **correlation** between sclerometric index and strength measured with compression tests on cylindrical carrots has turned out **nearly null**; the in site sclerometric tests cannot therefore be used in order to estimate the strength of the concrete in site, in the points where they have not been extracted carrots, Fig. 9.

- This result probably is attributable to the diffuse presence of gross inert, that they have influenced both the sclerometric index and the strength of carrots.

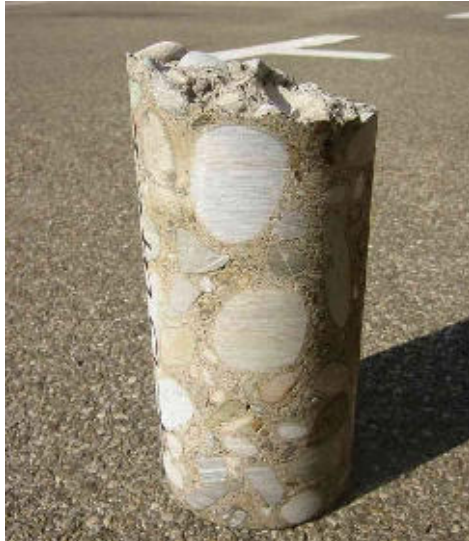
Fig. 10 Concrete carrots from B3 columns

The 79 carrots of $\varnothing 100$ mm of diameter and 250 mm of length have been extracted from different points along the columns height. After the crushing test, the way of rupture of such carrots has been examined, in order to establish their acceptability, based on the indications of norm UNI EN 12390-3:2003¹, that it distinguishes the type of “satisfactory” and “not satisfactory” rupture of the concrete carrots (Fgs. 10-12a,b).

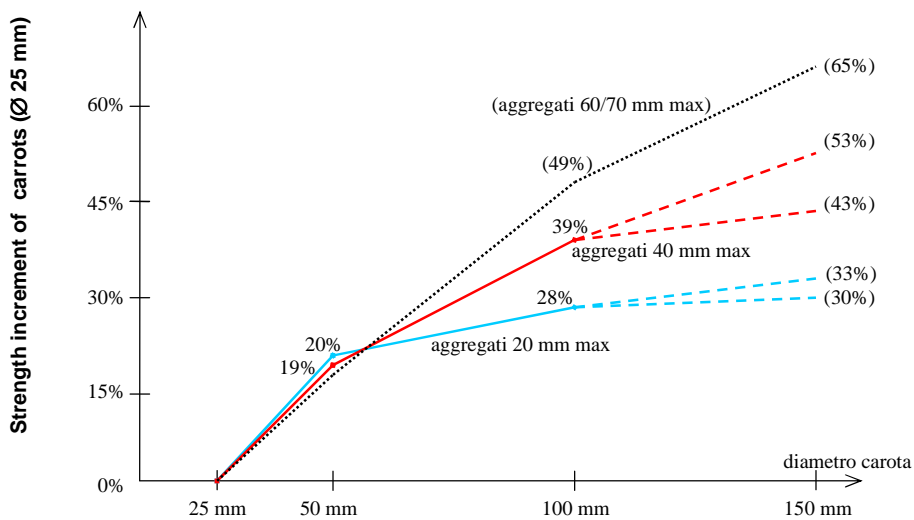
Fig. 13 Incidence of the dimension of the aggregate and the diameter of the carrot on its compression strength: hypothesis of extrapolation based on the data supplied from UNI EN 12504-1996

meaningfully influences the measured strength when is approached greater values of 1:3 approximately). It has been therefore carried out a prudential estimation of the effect negative on the which had resistance of the carrots to inert with greater diameter of 1:3 of the diameter of the carrot, extrapolating the data supplied based on the norm UNI EN 12504-1. The diagram of Figure 13 illustrates, joined from the continuous lines, the increments of the strength, regarding the carrot having 2 strength 5 mm of diameter, for several combinations of diameters of carrots and the maximum diameters of inert, on the base of the data supplied from cited norm UNI EN 12504-1. On line outlined, the increment, extrapolated graphically, of the to strength increasing of the diameter of the carrot it is illustrates. Without to enter in the details it can be asserted that it appears lawful and much prudential to preview that, if they had been used carrots of 200 mm of diameter, so as to have the maximum diameter of inert the not too much advanced one to 1/3 of the diameter of carrots, one would have been estimate strength Rck of carrots advanced at least 14% regarding that one measured with carrots of 100 mm of diameter.

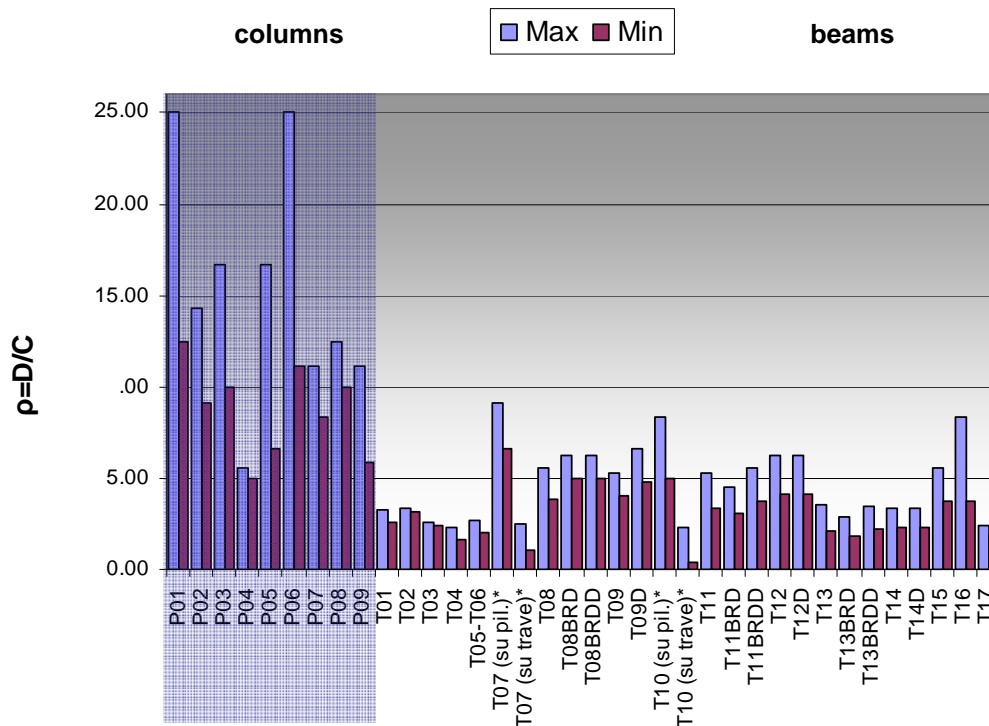
Fig 15 Values of p (calculated to constant axial stress) in the present state for all the elements of the structure grouped for type of section

The Ord. 3274 place two conditions for the applicability of linear dynamic analysis to the existing r.c. buildings: - **i) $p_{max}/p_{min} < 2$** ; - **ii) $p_{max} < 7$** for the columns and **$p_{max} < 15$** for the beams. **p** it indicates, for every structural element, the relationship between the bending moment supplied from the analysis and the resistant moment. The analysis evidences that the first condition of applicability ($p_{max}/p_{min} < 2$) for linear dynamic analysis does not turn out satisfied; in fact $p_{max}/p_{min} = 59$, more over of the suggested limit (2)from the norms. Also the second condition of applicability is not satisfied for the columns; in fact the p_{max} of the pillars it exceeds the limit of 7, while the p_{max} of the beams, Fig. 15, it is always inferior to 15 .
